# Buildings or Boats No Challenge for Concrete Cutters

**Ballast Removal Allows  
Smooth Sailing  
for Vehicle Transport Ferry**

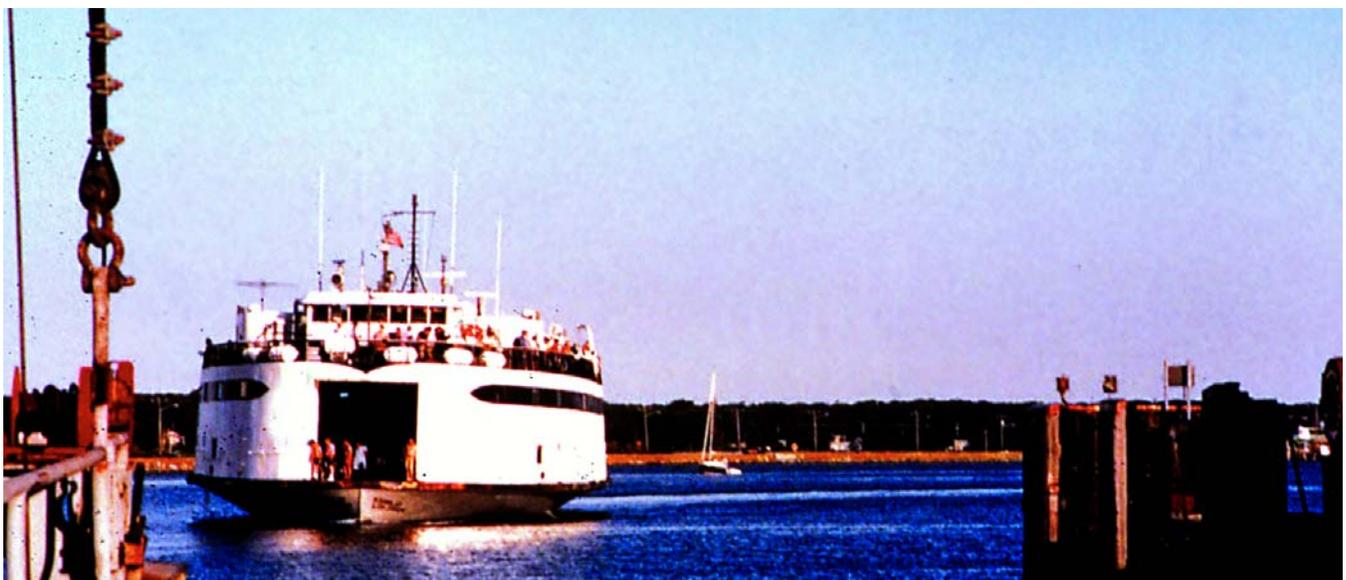
**Top:** Removing a large section of the ship's 9-foot-thick ballast was necessary to reduce its weight.

It was determined that the 9-foot-thick concrete ballast located in the ship's hull and situated below the top deck at mid-ship could be removed to reduce the weight. Marine engineers calculated that if two areas measuring 12 feet by 13 feet by 3 feet deep were removed from the 9-foot-thick ballast, the 70 tons of concrete removed would compensate for the additional steel.

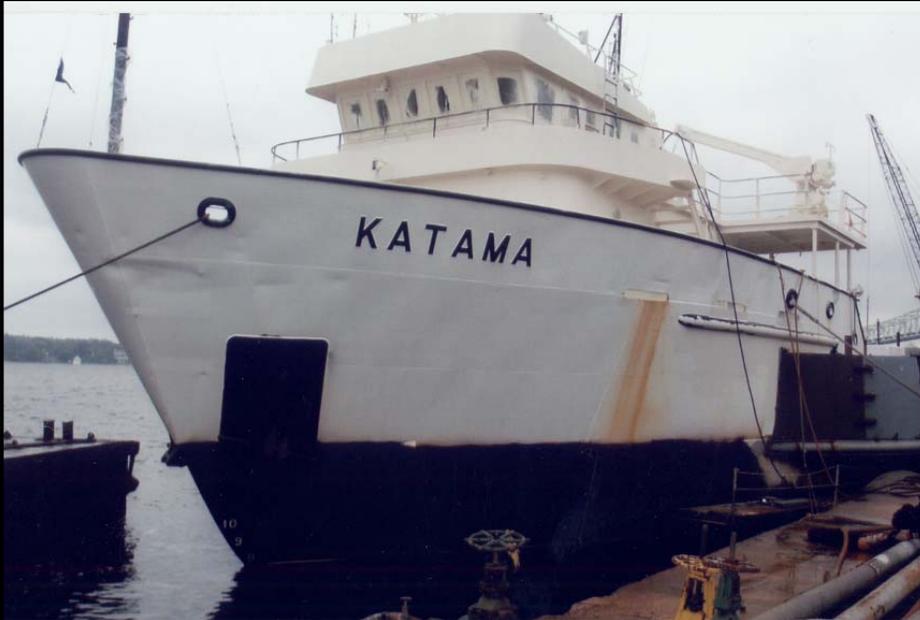
**Middle:** Using 110-V and hydraulic core drills, operators cored holes in a 12-inch on-center grid pattern.

Next, 2-inch-diameter by 36-inch-deep holes were cored using 110-V and hydraulic core drills from Diamond Products and core bits from Dimas. The holes were cored through the

remaining portion of ballast being removed in a 12-inch on-center grid pattern, allowing for the installation of the expansion agent that would help control the breaking pattern. After setting the expansion agent, ConCut operators left the work area alone for a 24-hour period to allow the agent to completely expand and break up the concrete. Then operators set 3/4-inch drop-in anchors into the broken pieces and rigged them for crane removal. The crane and crane operator were provided by the general contractor. Hydraulic hoe rams were initially considered as a method to break up the concrete ballast, but contractors were concerned that they would not be able to control the breaking pattern, thus risking damage to the bulkheads and the remaining ballast areas. Also, with the unpredictability of this method, ConCut did not want to jeopardize the timetable.

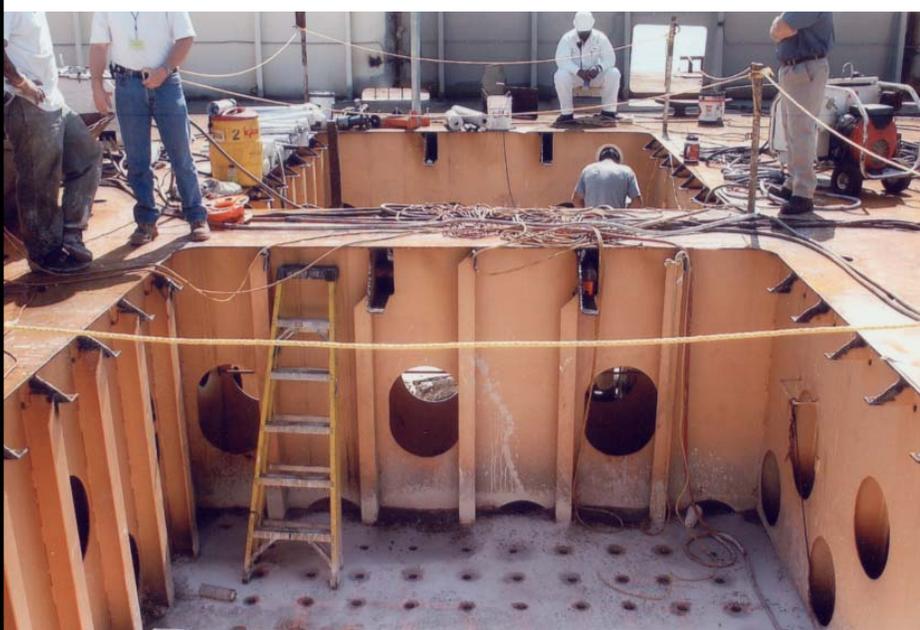
**Bottom:** Core drilling isolated the ship's bulkheads and allowed operators to drill with limited access.

Concrete core drilling with diamond tools was specified for removal for a few reasons. With both ballasts being 9 feet thick and encased with bulkheads, there was limited access for the operators as well as the equipment. There could be no damage to the bulkheads, which butted right up to the ballast concrete that would be removed. Stitch drilling would be fast and efficient, allowing operators to complete the job in the 12-day window allotted. The Katama had to leave port no later than May 14, and the general contractor needed five days to complete its work after the ballast removal.

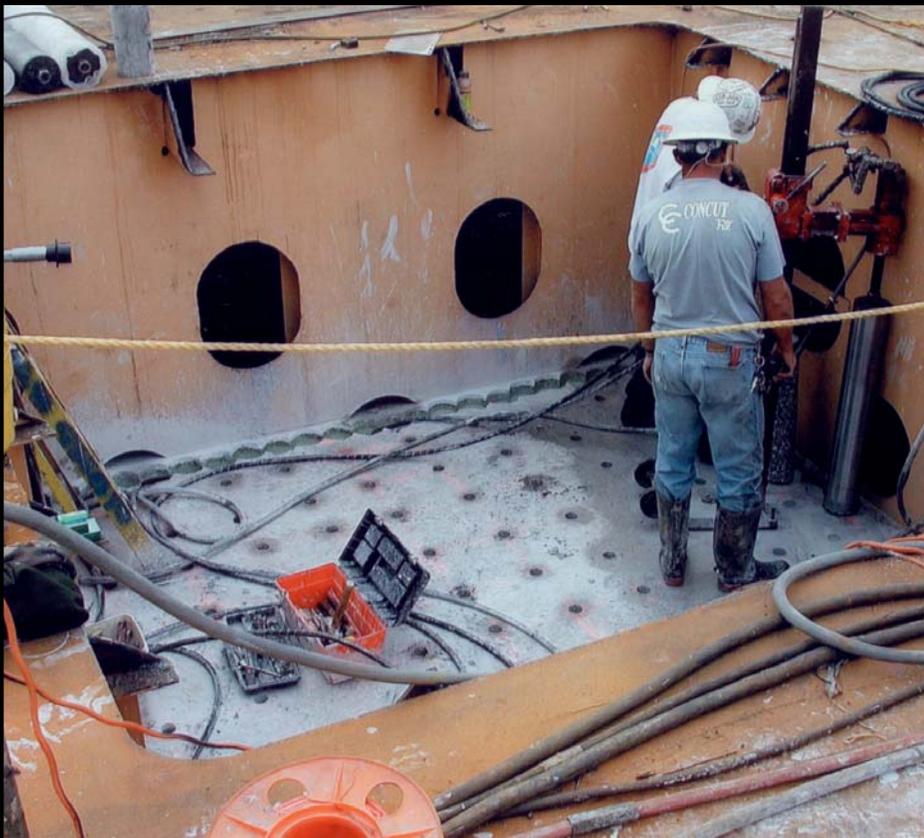
Top: Line drilling around the perimeter created room for the concrete to shift during the breaking process.

ConCut operators began by line drilling 6-inch-diameter by 36-inch-deep holes around the perimeters of the two 12-foot by 13-foot areas in order to create a 6-inch-wide gap between the concrete ballast and the steel bulkheads. This gap allowed room for the concrete to shift during the expansion process, preventing it from causing stress or damage to the ship's bulkheads.

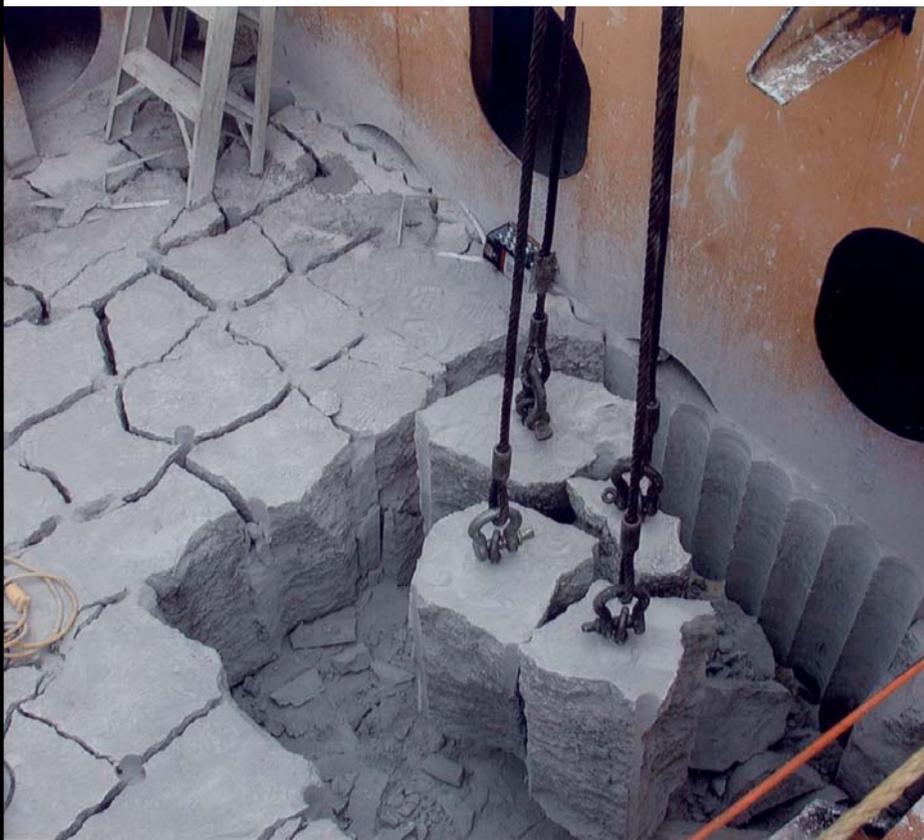
Bottom: Operators removed almost 70 tons of concrete ballast in 12 days.

In all, ConCut operators cored 210 holes measuring 6 inches in diameter by 36 inches deep and 288 holes measuring 2 inches in diameter by 36 inches deep. They used 160 bags of DEXPAN expansion agent supplied by Archer Company for the controlled breaking of the concrete ballast. They successfully removed 67 tons of concrete in the 12 days allotted with a 3- to 4-man crew.
